ONLY WAY LAKE DAM

SALINE COUNTY, MISSOURI

MO. 10111

PHASE 1 INSPECTION REPORT
NATIONAL DAM SAFETY PROGRAM

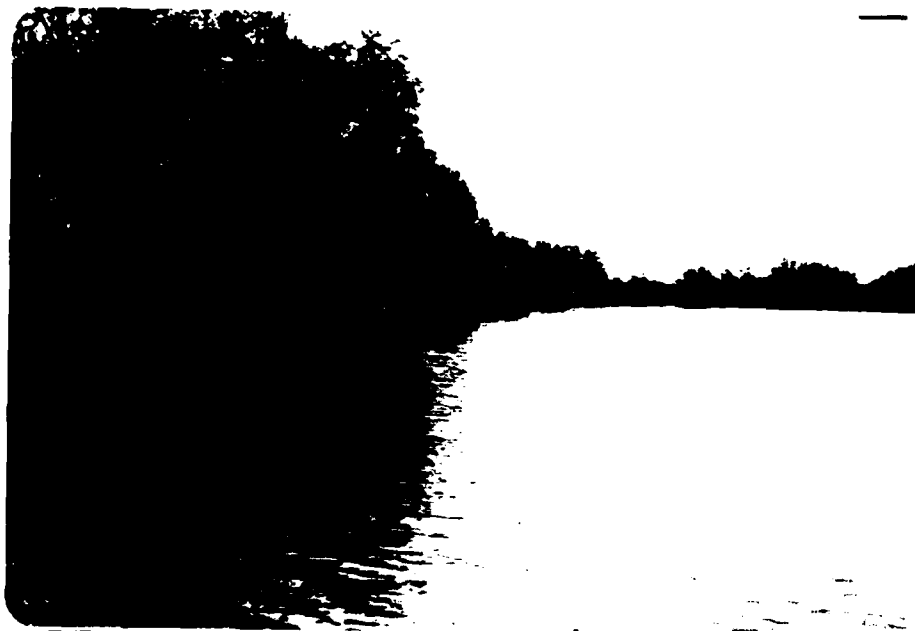
- (2) Upstream Slope. The upstream face is nearly vertical from the crest to the waterline and is plated with concrete slabs, rubble and limestone cobbles. Very little erosion was noted along the face. Several good sized trees are growing on the upstream crest and slope. No slides or abnormal deformations were noted on the slope.

PHOTO NO. 3 - UPSTREAM FACE OF DAM TAKEN FROM DIVING PLATFORM
LOOKING TO RIGHT

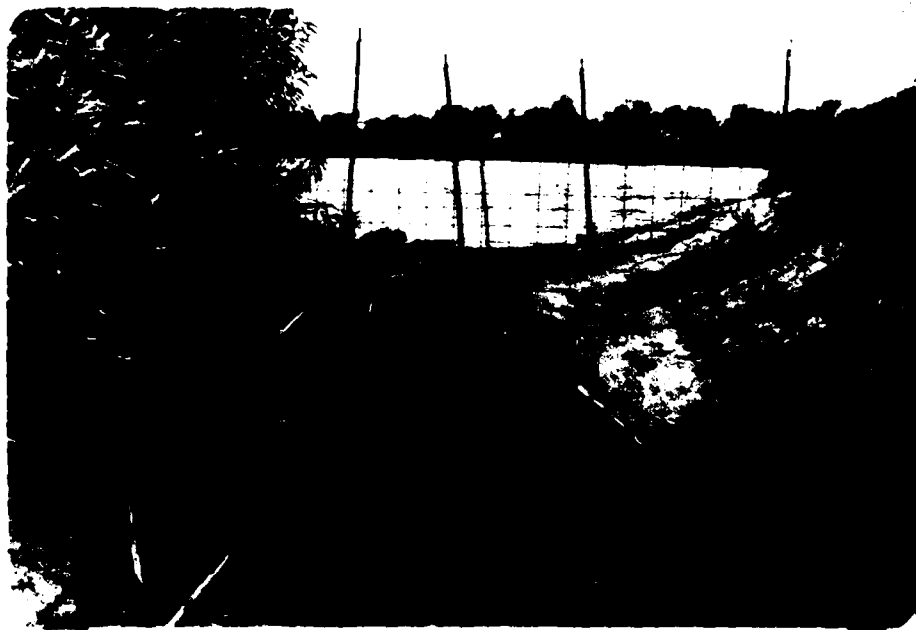
PHOTO NO. 7 - LOOKING UPSTREAM AT ENTRANCE TO EMERGENCY
SPILLWAY

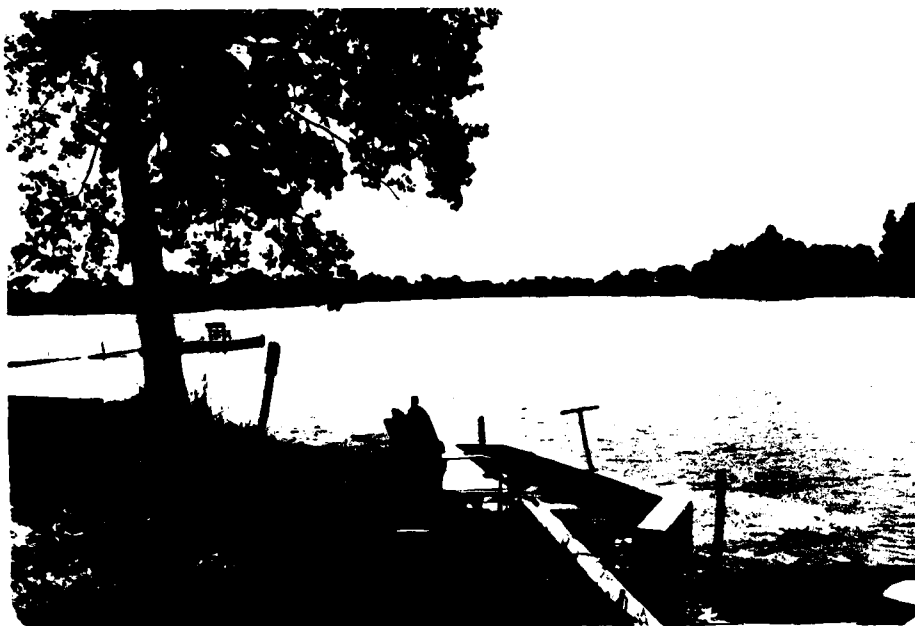
PHOTO NO. 14 - PRINCIPAL SPILLWAY HEADWALL. AUGER SET IN
CRACK IN CONCRETE

- (4) The headwall of the principal spillway should be repaired to prevent further deterioration.
- (5) A program of regular inspection and maintenance should be initiated.

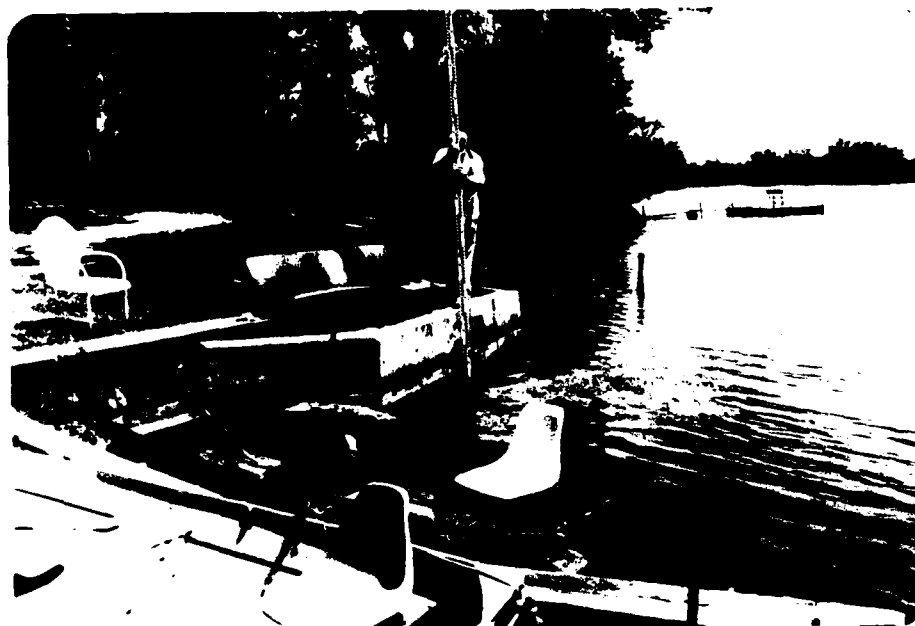
PHOTO NO. 15 - PRINCIPAL SPILLWAY INLET
